**HISTORIC PRESERVATION REVIEW BOARD
STAFF REPORT AND RECOMMENDATION**

Landmark/District:	Anacostia Historic District	(x) Consent
Address:	1644 U Street SE	
Meeting Date:	January 26, 2017	(x) Addition
Case Number:	17-141	
Staff Reviewer:	Tim Dennée	(x) Permit

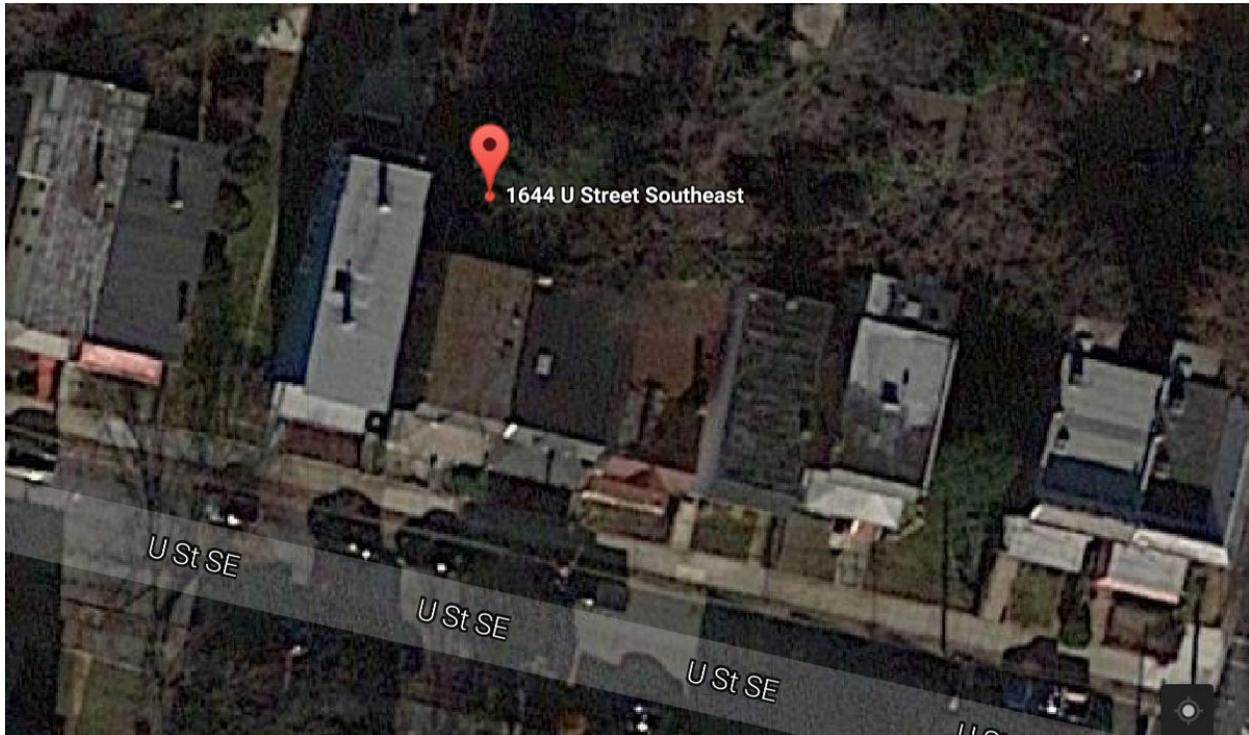
The house's rear wall would be mostly demolished, but its other walls and its floor and roof framing would remain. The base of the rear addition is proposed to be painted, poured concrete.

Most of the historic buildings on the square have not been extended, but a few have. Neither 1644 U nor its attached twin have had additions, but both have rear porches. The rear porch would be removed in order to construct an nineteen-and-a-half-foot-deep addition. The addition would have an approximately five-foot side yard (assuming zoning approval), so that the addition would be a fairly typical ell. As the addition is subordinate to the 34-foot-deep main block (and its front porch)—being lower, narrower and shallower, with a conventional side-shedding roof—its massing seems sufficiently compatible to the character of the subject property. As the lot also contains a garage, the new construction would presumably reach the limit of the site's potential lot occupancy under the zoning regulations.

A sided wing of this size and type is sufficiently compatible with a modest brick home and is generally compatible with a modest and mostly frame historic district. The proposed siding is fiber-cement, which the Board has found generally acceptable as a substitute for wood on new construction and additions in this historic district and others. Pre-1930s siding was generally of narrow exposure, so for consistency and to mitigate the flatness of fiber-cement, the siding should be no wider than six-inch exposure (while being smooth-surfaced, rather than textured).
